ExxonMobil's Toxic Torrance Refinery Failure, 2015

ChE333T

Spring 2019

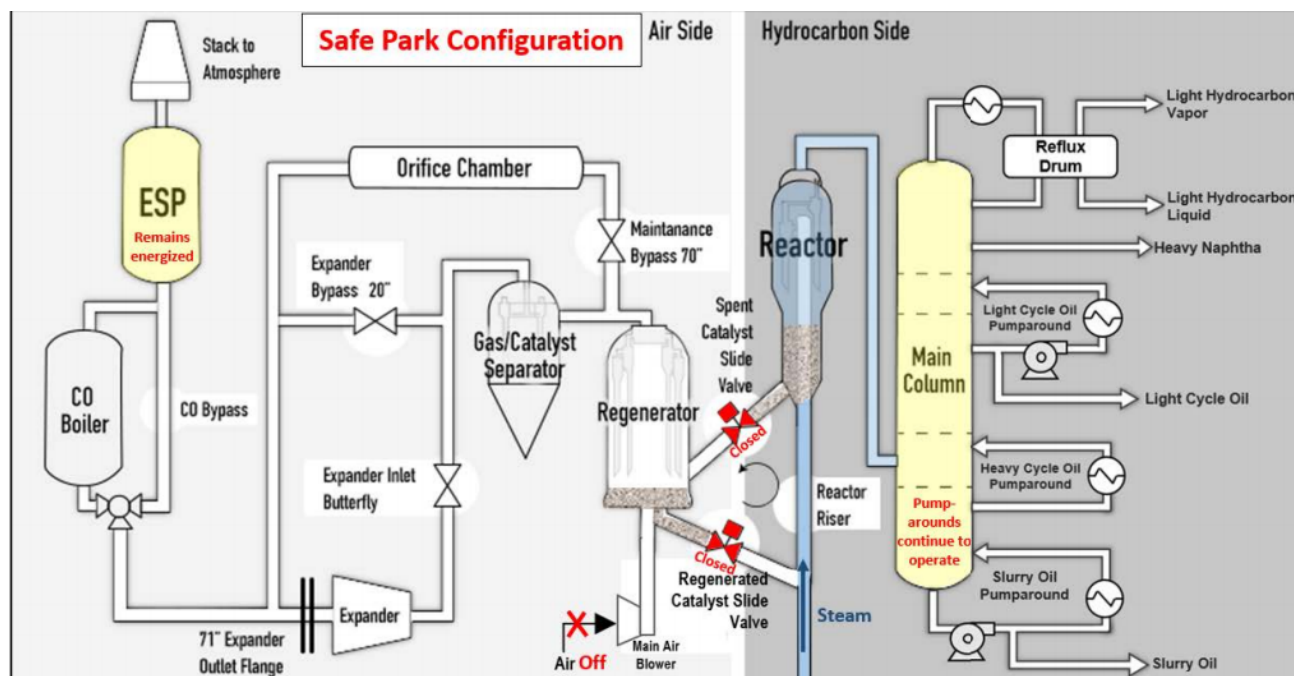
Another integral aspect of the FCC unit is the “Safe Park” mode. Safe Park is a term used by ExxonMobil to define the status of a unit that has taken a series of automatic actions after sensors detect dangerous conditions. Safe Park mode does not fully shut down the system, but rather, the system is left in an emergency idle state where sections of the system remain in operation as shown in Fig. 6 (CSB, 2017, p.17). Although many sections shut down, the main column pumps remain energized, the ESP remains activated, and the hydrocarbons within the system remain in the unit (CSB, 2017, p.16). The disconnect between Safe Park and a full system shutdown results out of a desire to maximize profits. Leaving certain units within the system energized reduces restart time, minimizing gasoline loss. As a result of initiating Safe Park, the air side of the FCC no longer provides an air flow into the hydrocarbon side, so the backflow of hydrocarbons into the sparking ESP is an imminent danger. Therefore, the system enacts

automatic safety precautions, including the closure of the SCSV and the RCSV, which blocks any connection between the air side and hydrocarbon side. Additionally, the hydrocarbon feed as well as the main air blower stop, allowing the normally aerated catalyst in the regenerator to settle onto the closed RCSV and the normally aerated catalyst in the reactor to settle onto the closed SCSV (CSB, 2017, p.17). Ultimately, this action helps to further block the only two connection points between the two sides due to catalyst buildup on the valves. Finally, steam valves are opened to allow steam to flow in place of the halted hydrocarbon feed (CSB, 2017, p.17). The steam applies a constant pressure towards any remaining hydrocarbons to prevent backflow into the air side. In summary, the closure of the SCSV and RCSV and the catalyst build up on the valves provide physical barriers to prevent hydrocarbon backflow. Also, the constant pressure from the forward flowing steam helps to further aid this physical barrier. Essentially, two measures are taken to prevent backflow of hydrocarbons: creating a physical barrier and applying pressure.

Figure 6. Depiction of Safe Park mode used in the Torrance Refinery, where specific units cease operation (CSB, 2017, p.17).

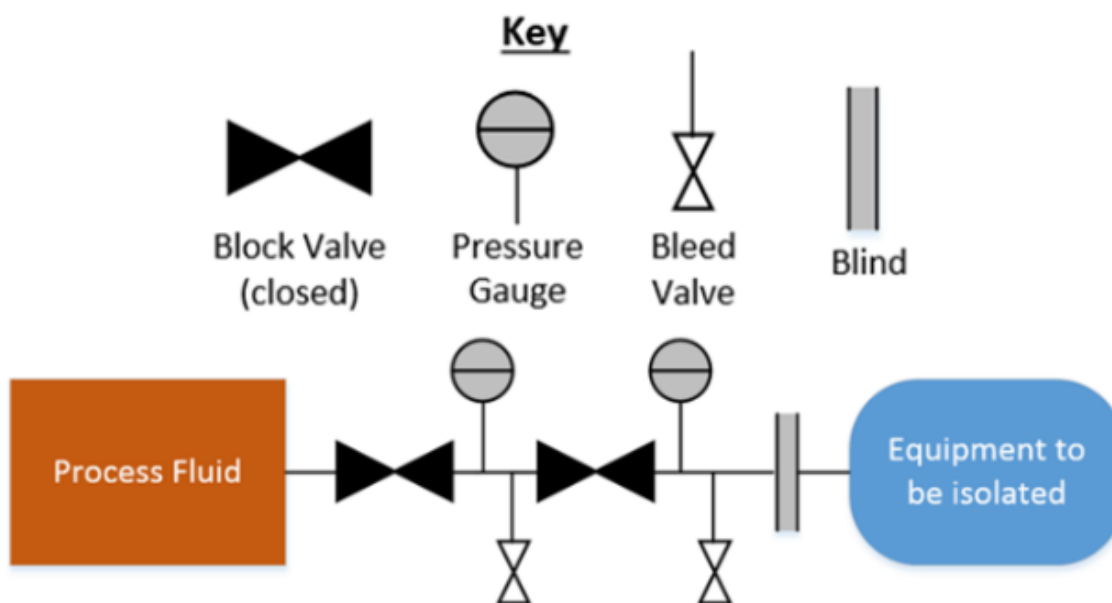
The Block and Bleed method involves the use of a block valve to stop the flow of process fluid to the piece of equipment that is to be isolated (CSB, 2017, p.26). Then, a bleed valve is placed between the block valve and the semi-isolated section to remove any remaining process fluid. Finally, a pressure gauge is added to ensure correct bleeding and to check for leaks (CSB, 2017, p.26). When the block and bleed method is combined with blinding, “blinds” are placed at

the inlet and outlet of the isolated section as well. A blind is simply a disc of metal placed inside of the pipe to physically obstruct any process fluid from entering the isolated area (CSB, 2017, p.26). Claiming that space did not allow for the traditional isolation method of Double Block and Bleed with blinding, the managers decided to follow a “Variance” procedure performed in 2012, that called for a less strict isolation method. A diagram of the traditional Double Block and Bleed isolation method is displayed in Fig. 7 (CSB, 2017, p.26).

Figure 7. Diagram of the Double Block and Bleed Method with blind installed (CSB, 2017, p.26).

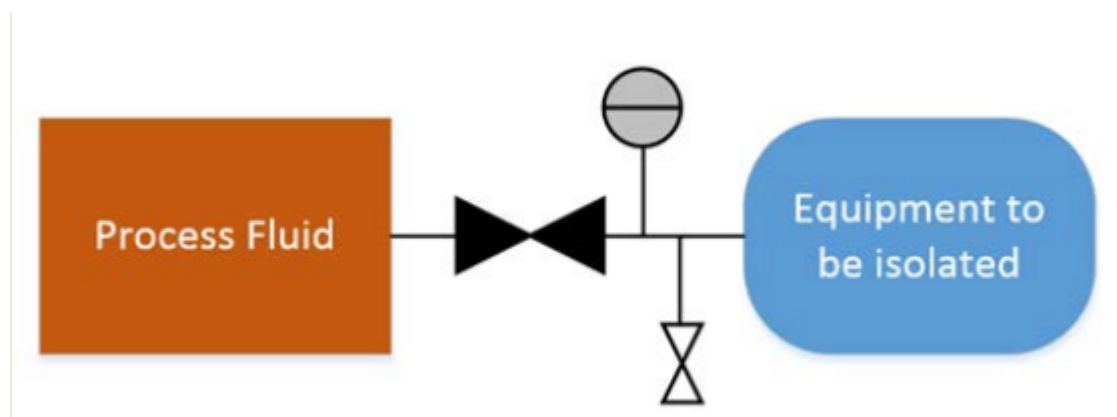
In 2012, a few years prior to the Torrance refinery explosion, ExxonMobil had a similar issue when the expander put the system into Safe Park mode. (CSB, 2017, p.29). The engineers working to solve the issue at the time had no desire to shut down the entire system for isolation because this would result in the loss of hydrocarbons to create gasoline. Instead, they designed and conducted a variant plan which avoided the Double Block and Bleed isolation method, and, instead, used a Single Block and Bleed method (CSB, 2017, p.29). This method eliminated the

installation of a blind at the inlet entirely as seen in Fig. 8 (CSB, 2017, p.26). In order to compensate for the absent second block and inlet blind, the variance added several necessary conditions: the SCSV and RCSV needed to be fully functioning and in a closed position, steam flow to the reactor had to be greater than 2,000 pounds per hour, and a blind must be installed at the expander outlet (CSB, 2017, p.30).

Figure 8. Diagram of the Single Block and Bleed Method used by Variance (CSB, 2017, p.26).
